**COMPANION FLANGE/FLANGE YOKE STYLE
(S.A.E., DIN AND T-TYPE)
SPICER LIFE SERIES 55, 70, 90, 100, 140, 170 & 250**

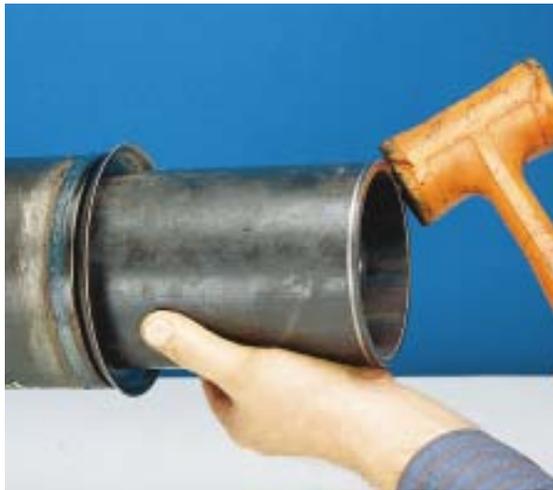
Photo 134

1. Wipe the bearing surface of the midship tube shaft with a fine emery cloth.
2. Install a new slinger (included in center bearing replacement kit) on the midship tube shaft using a section of tubing to avoid damaging slinger. Make sure the slinger is completely seated against the midship tube shaft shoulder. (See photo 134, below.)

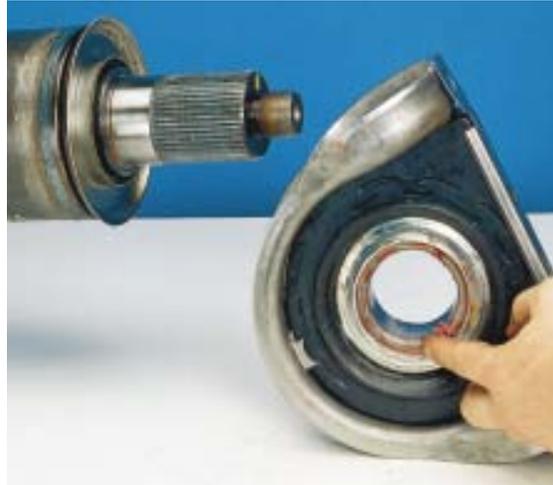
Photo 135

3. Before installing the new center bearing assembly, be sure to fill the entire cavity around the bearing with a waterproof lubricant. (See photo 135, top right.) Enough lubricant must be applied to fill the cavity to the extreme edge of the slinger surrounding the bearing. Lubricants **must** be waterproof. See Table NN, top right, for recommended lubricants. ▲ See warning, below.

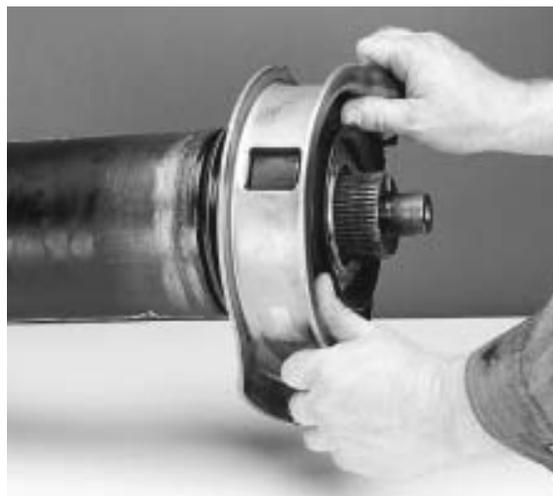
Photo 136

4. Carefully align the center bearing assembly with the ground surface of the midship tube shaft. Physically push the center bearing onto the midship tube shaft. (See photo 136, below.)

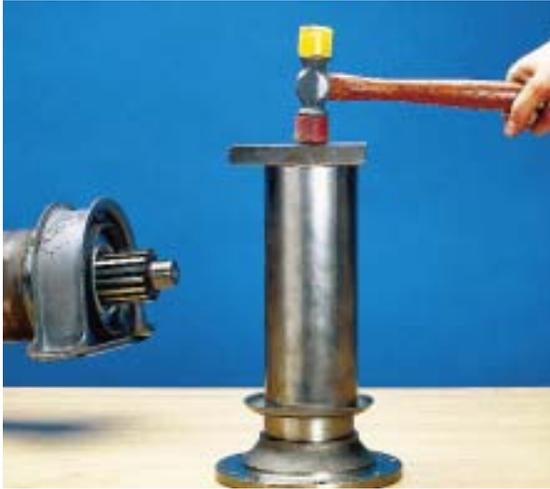
Photo 137

5. Press remaining slinger onto the companion flange using a section of tubing to avoid damaging slinger. (See photo 137, above.)

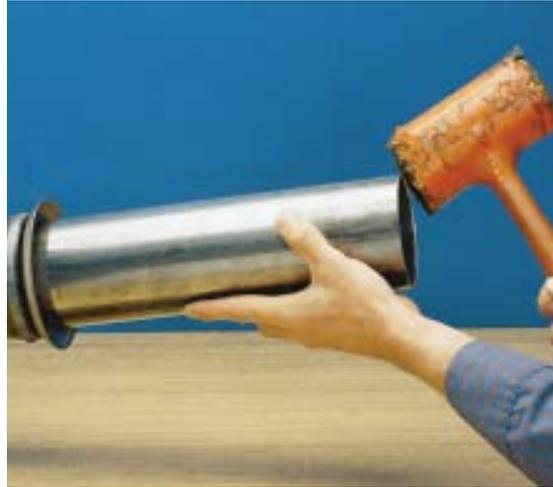
Photo 138

2. Install a new slinger (included in center bearing replacement kit) on the midship tube shaft using a section of tubing to avoid damaging slinger. Make sure the slinger is completely seated against the midship tube shaft shoulder. (See photo 138, top right.)

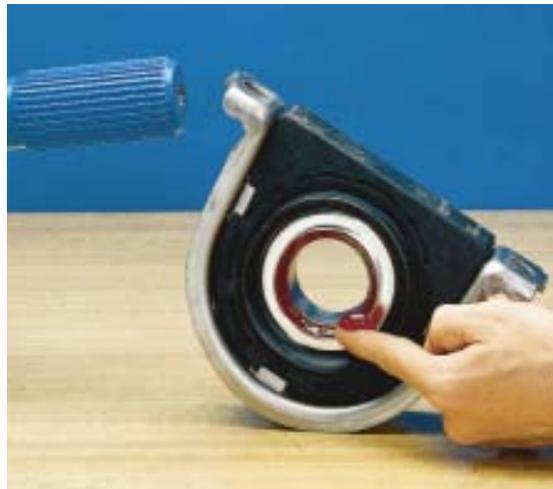
Photo 139

3. When replacing a center bearing assembly, be sure to fill the entire cavity around the bearing with a waterproof lubricant (see photo 139, center right.) Enough lubricant must be applied to fill the cavity to the extreme edge of the slinger surrounding the bearing. Lubricants **must** be waterproof. See Table QQ, bottom right for recommended lubricant.

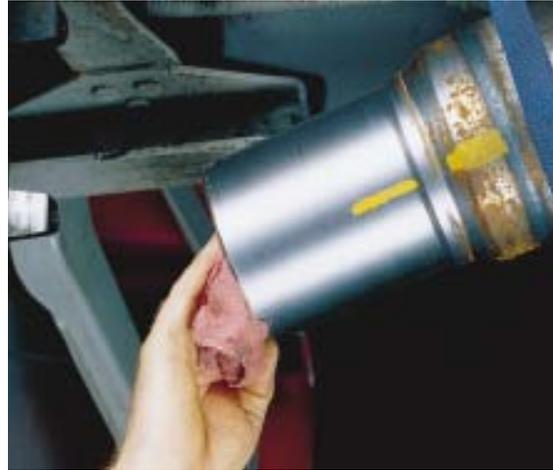
Photo 140

1. Clean **ALL** grease from yoke shaft and spline sleeve. Make sure grease-cutting solvent does not intrude into the tube through the vent hole in the spline sleeve plug. **Be sure the phasing marks made during disassembly are not removed.** (See photo 140, top right.)

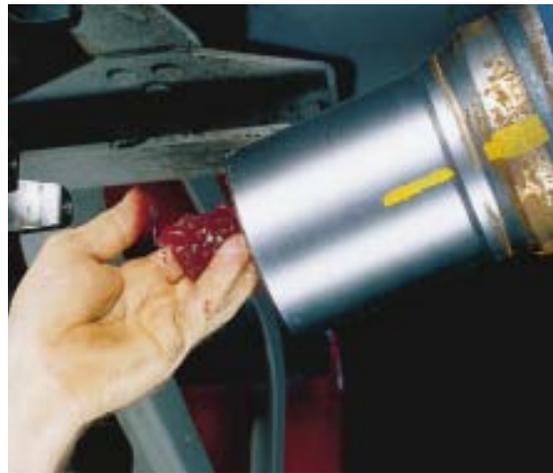
Photo 141

2. After all traces of grease-cutting solvent have been removed from yoke shaft and spline sleeve, apply enough N.L.G.I.*, E. P. Grade 2 grease (provided in slip member boot replacement kit) to fill the entire length of all teeth in the spline sleeve (see photo 141, right.) Wipe any excess grease on the **teeth** of the yoke shaft. ▲ See warning, below.

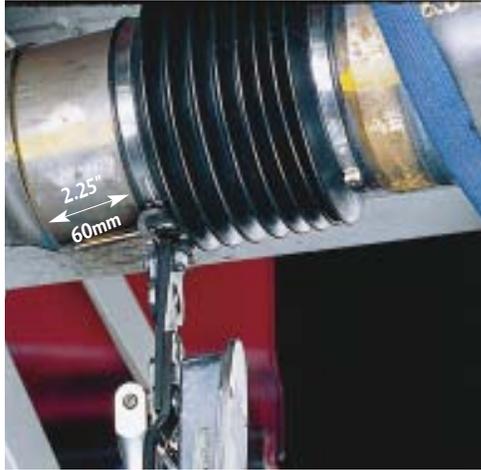
Photo 142

3. Measure and place a mark 2.25 inches (55-60mm) from yoke shaft shoulder with a marking stick, paint marker or other legible marking device. (See photo 142, above.)

5. Collapse the boot and insert the yoke shaft into the splined sleeve, **making sure phasing marks are in line**. Position the end of the boot at the 2.25 inches (55-60mm) mark made on the yoke shaft shoulder and tighten boot clamps to the specified torque. (See photo 142, above.)

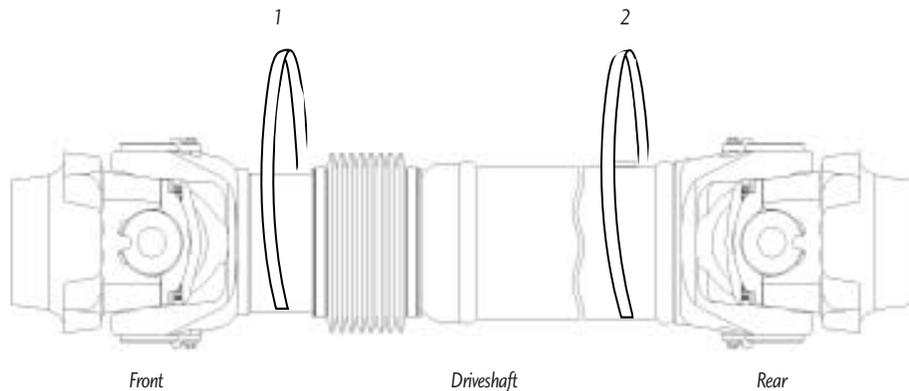
Figure Z.

5. **Be sure the second support strap is in place, as illustrated in Figure Z, page 136.** It may be necessary to

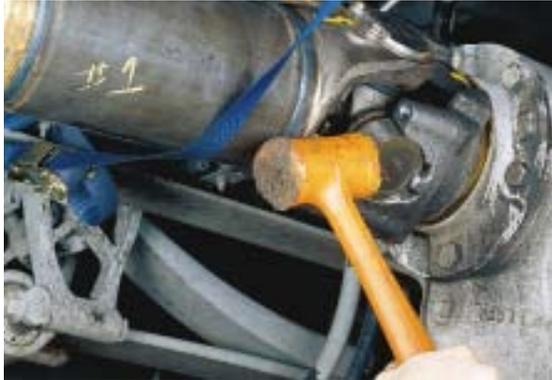
Photo 143

3. Working from the **front end**, use a soft-faced hammer to tap the universal joint into the end yoke. Make sure to align

the universal joint in end yoke, **matching up the phasing marks made during removal to ensure original driveshaft orientation.** (See photo 143, above.)

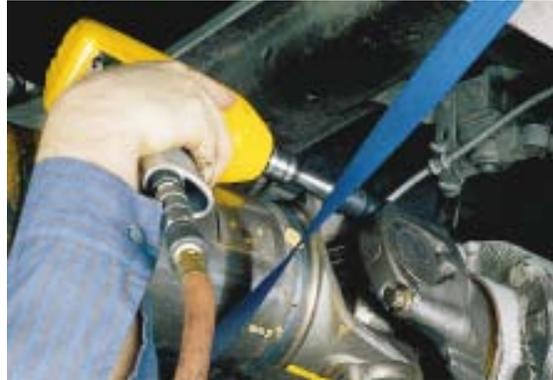
Photo 144

4. Install the bearing retainers or **new** stamped straps and **new bolts** (see photo 144, top right.) Torque the bolts down evenly and to required specifications. Check to make sure the bearing cup assemblies are fully seated in the yoke ears.

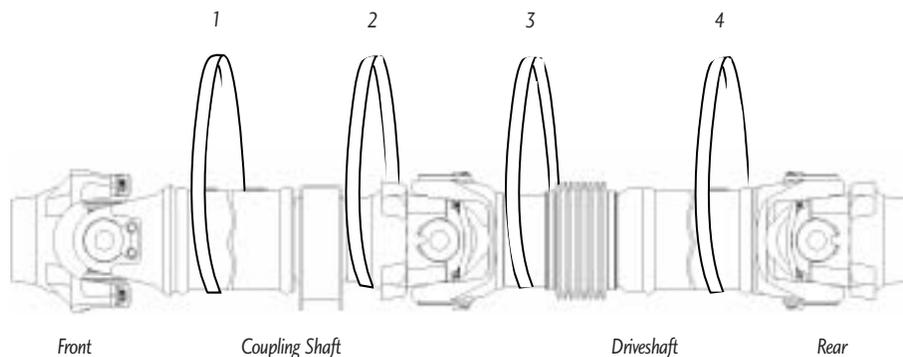
Figure AA

5. **Be sure the second support strap is in place, as illustrated in Figure AA, page 138.** Lift the center bearing to the center bearing bracket on the cross member of the frame. Install proper center bearing bracket bolts, per vehicle manufacturer's recommendations. (See photo 145, above.) Torque bolts to vehicle manufacturer's required specifications. ▲ See warning, below.

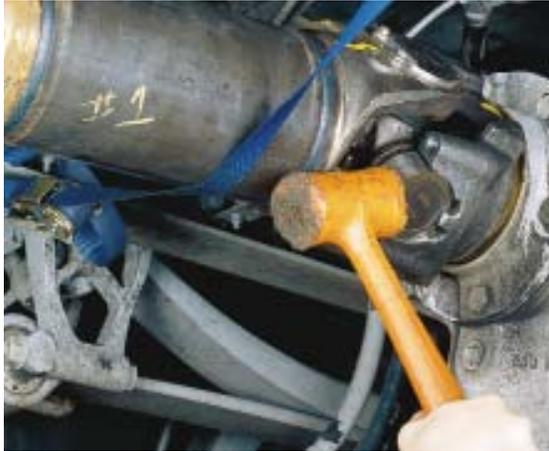
Photo 146

7. Working from the **rear end**, use a soft-faced hammer to tap the universal joint into the rear end yoke. Make sure to align the universal joint in the rear end yoke, **matching up phasing marks made during removal to ensure original driveshaft orientation**. (See photo 146, above.) ▲ See warning, below.

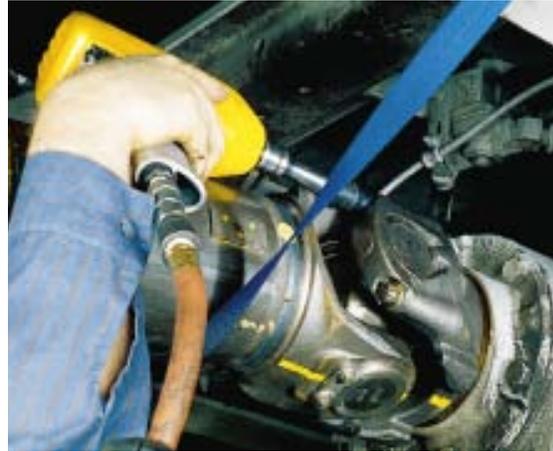
Photo 147

8. Install bearing retainers or **new** stamped straps and **new** bolts. (See photo 147, above.) Torque the bolts down evenly and to required specifications. Check to make sure the bearing cup assemblies are fully seated in yoke ears. Table WW, right. ▲ See warning, below.

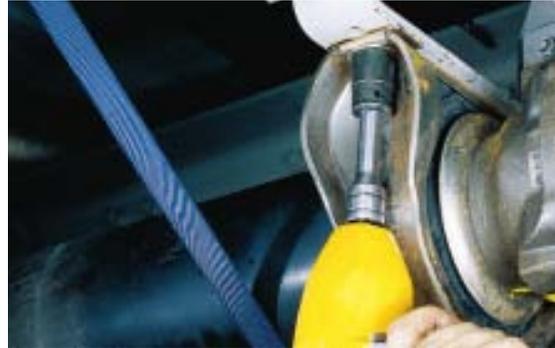
Photo 148

6. Be sure the second support strap is in place, as illustrated in Figure BB, page 142. Lift the center bearing to the center bearing bracket on the cross member of the frame. Install proper center bearing bracket bolts, per vehicle manufacturer's recommendations. (See photo 148, top right.) Torque bolts to vehicle manufacturer's required specifications. ▲ See warning, below.

10. Be sure the fourth support strap is in place, as illustrated in Figure BB, page 142. Lift the center bearing to the center bearing bracket on the cross member of the frame. Install proper center bearing bracket bolts, per vehicle manufacturer's recommendations. (See photo 148, page 143.) Torque bolts to vehicle manufacturer's required specifications. ▲ See warning, below.

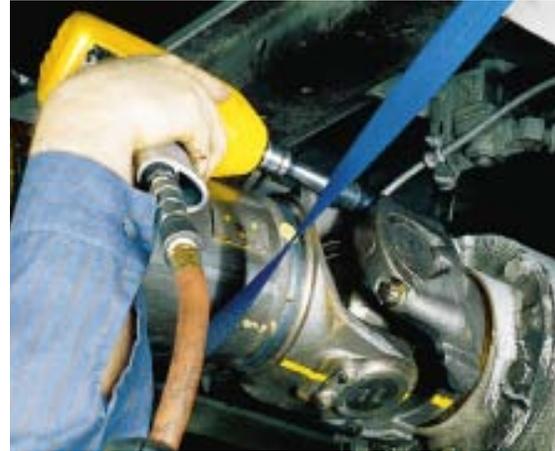
Photo 150

14. Install bearing retainers or **new** stamped straps and **new** bolts. (See photo 150, page 144). Torque the bolts down evenly and to required specifications. Check to make sure the bearing cup assemblies are fully seated in yoke ears. Table ZZ, Page 144.

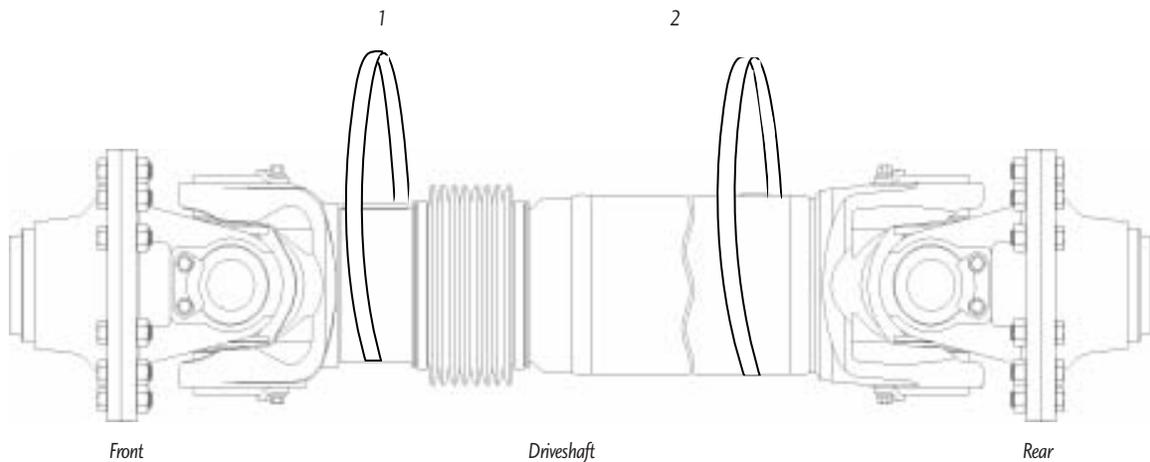
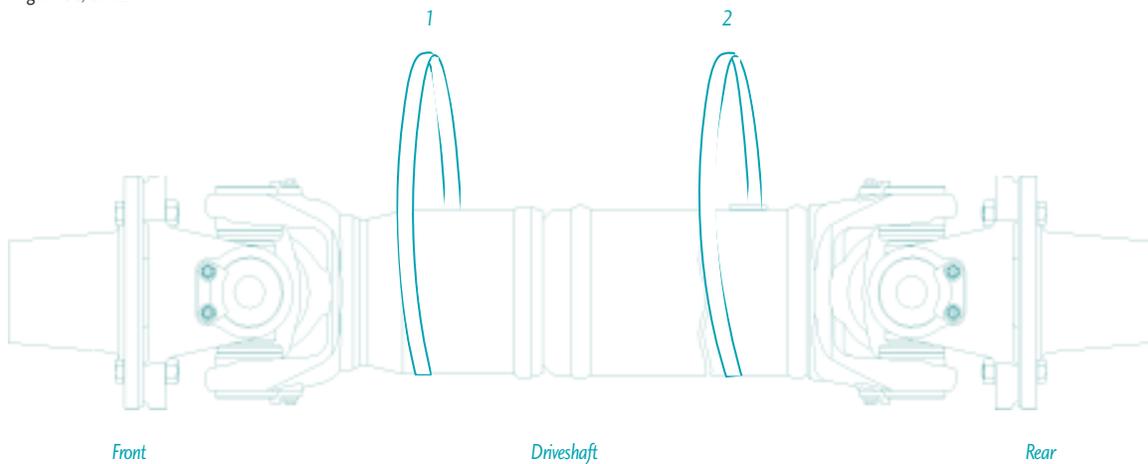
Figure CC, S.A.E.

Figure DD, DIN and T-Type

5. Be sure the second support strap is in place, as illustrated in Figure CC or DD, page 147. It may be necessary to collapse slip member assembly to allow clearance to install the driveshaft into the front companion flange.

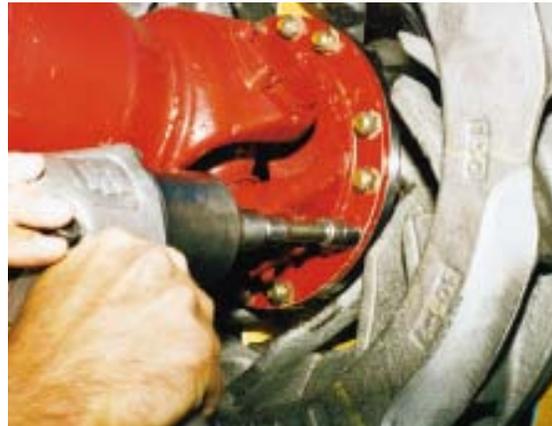
Photo 151

4. Install **new bolts**, washers (if required) and nuts. (See photo 151, above.) Reference hardware specifications, Table BBB, above. Bolts must be torqued to required specifications. ▲ See warning, below.

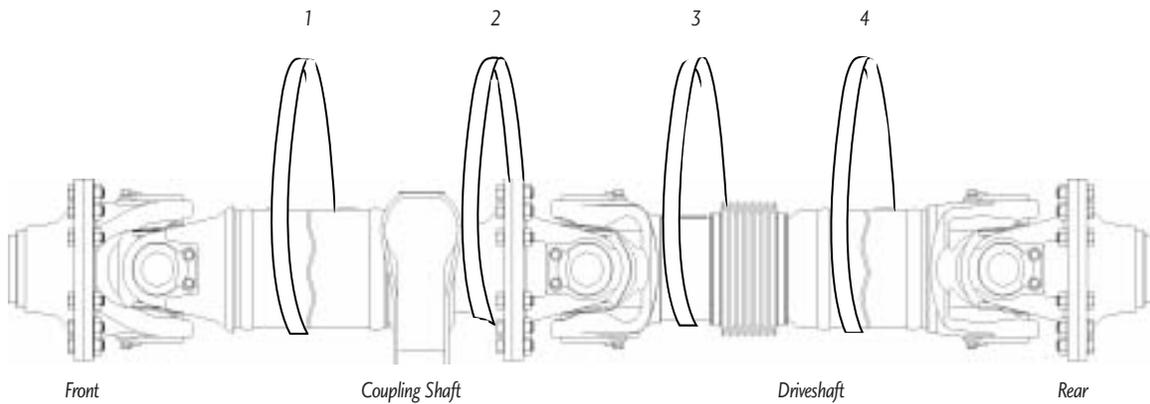
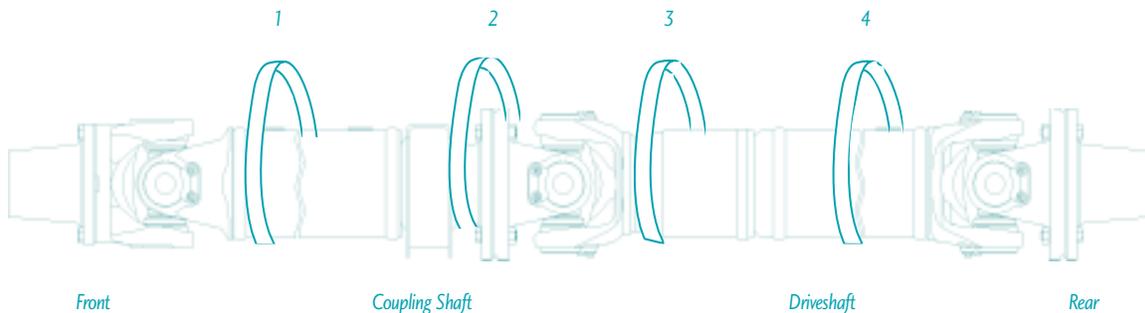
Figure EE, S.A.E.

Figure FF, DIN and T-Type

5. Be sure the second support strap is in place, as illustrated in Figures EE or FF, page 149. Lift the center bearing to the center bearing bracket on the cross member of the frame. Install proper center bearing bracket bolts per vehicle manufacturer's recommendations. Torque bolts to vehicle manufacturer's specifications. ▲ See warning, below.

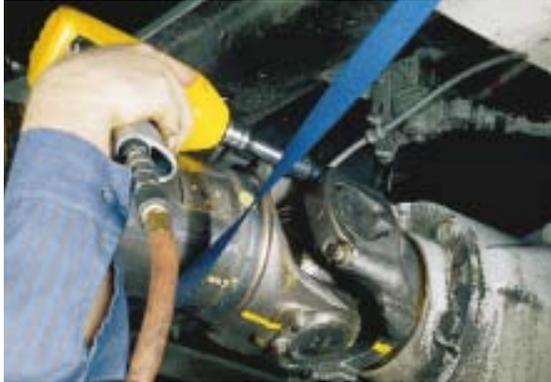
Photo 152

4. Install **new** bolts, washers (if required) and nuts. (See photo 152, page 151.) Reference hardware specifications, Table CCC, above. Bolts must be torqued to required specifications. ▲ See warning, below.

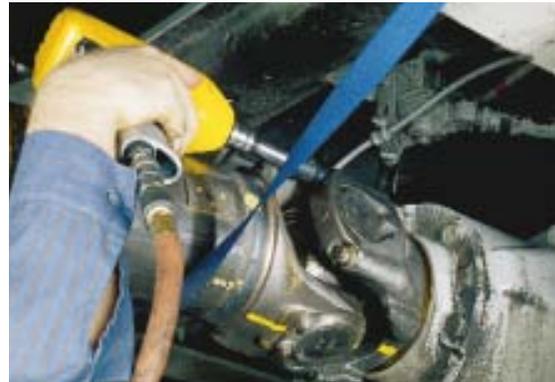
Photo 153

5. Install **new** bolts, washers (if required) and nuts. (See photo 153, above.) Reference hardware specifications, Table DDD, above. Bolts must be torqued to required specifications. ▲ See warning, below.

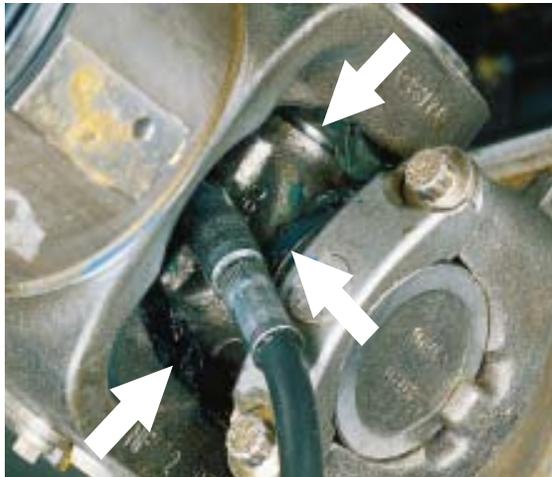
Photo 14

Make sure **fresh** grease is evident at all universal joint bearing seals. (See photo 14, below.)

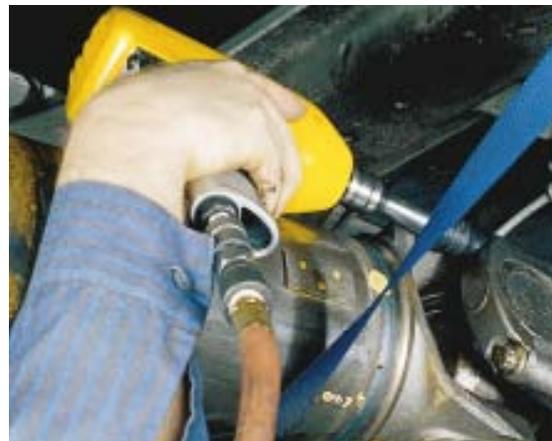
Photo 15

5. Remove the bearing retainers and bolts at the effected universal joint. Reference bolt specifications, Table H, page 28. (See photo 15, below.) Bearing retainer bolts with nylon lock patch **CANNOT** be reused. Loosening or removing bearing retainer bolts requires replacement of used bolts with new. ▲ See warning, below.

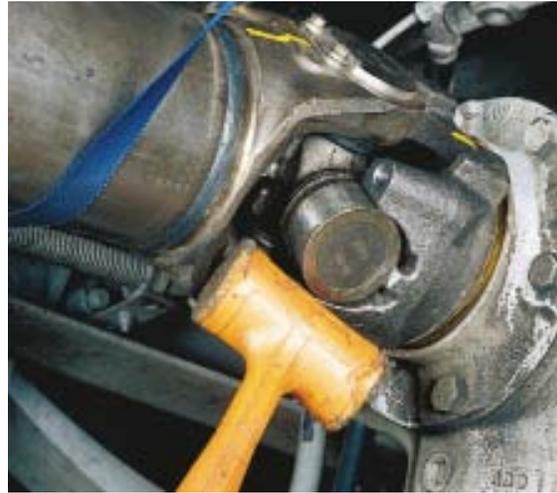
Photo 17

6. It may be necessary to unseat bearing cup assemblies by tapping on yoke or bearing cup with a soft-faced hammer. (See photo 17, above.) Once the bearing cup assemblies are free, allow the driveshaft to rest on support strap.

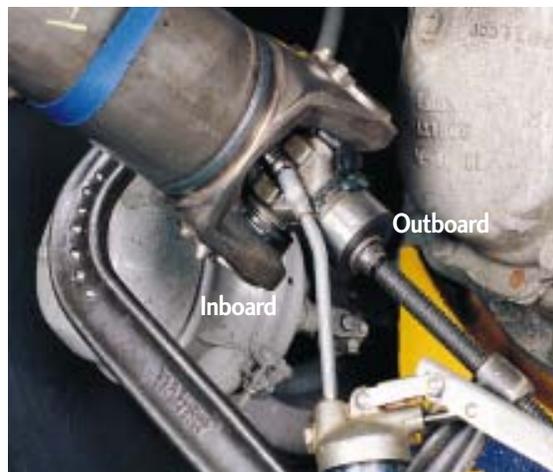
Photo 18

7. Apply a c-clamp around the outboard bearings. Apply grease gun pressure. Completely purge both inboard bearings. (See photo 18, below.)

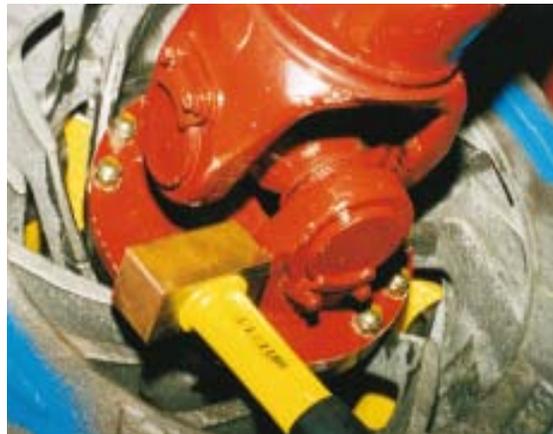
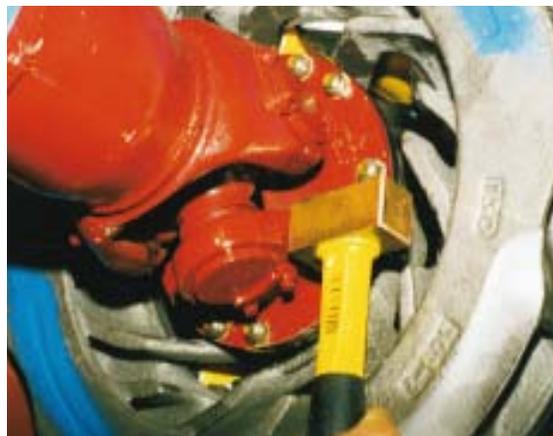
1. Utilizing a brass hammer and wearing safety glasses, sharply strike yoke on inboard and outboard lug ears **once**, to firmly seat bearings against spring tabs and relieve tension across span. ▲ See warning, below. Rotate shaft 180 degrees and repeat procedure on opposite inboard and outboard lug ears. (See photos 19 & 20, below.)

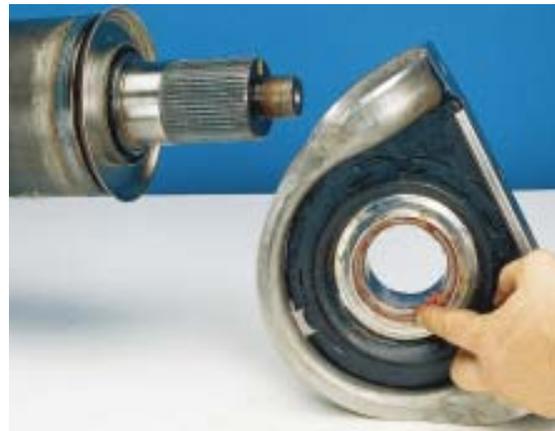
Photo 23

However, when replacing a center bearing assembly, it is necessary to fill the entire cavity around the bearing with waterproof grease to shield the bearing from water and contaminants. The quantity of lubricant should be sufficient to fill the cavity to the extreme edge of the slinger surrounding the bearing. (See photo 23, below.)

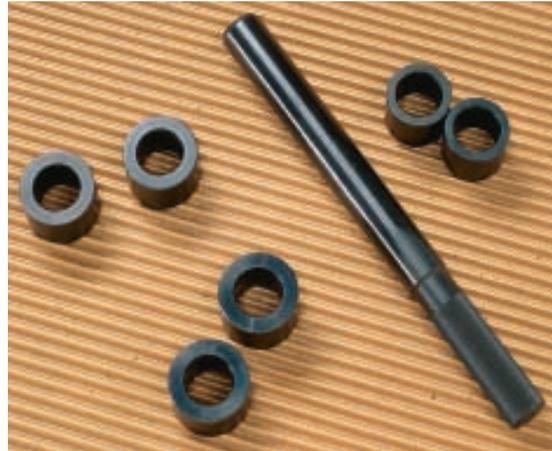
Photo 24, Spicer Alignment Bar, Quick Disconnect Style

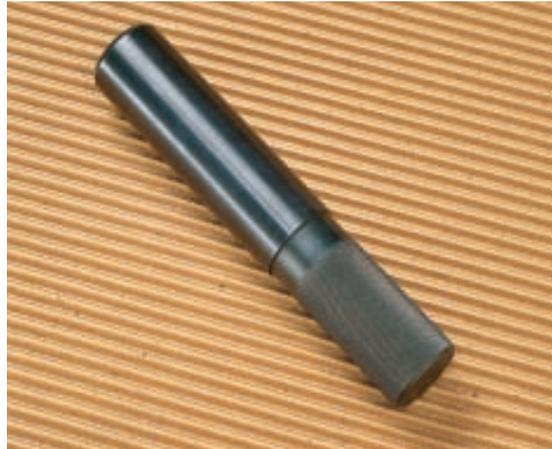
Photo 25, Spicer Alignment Bar, Companion Flange/Flange Yoke Style (S.A.E., DIN and T-Type)

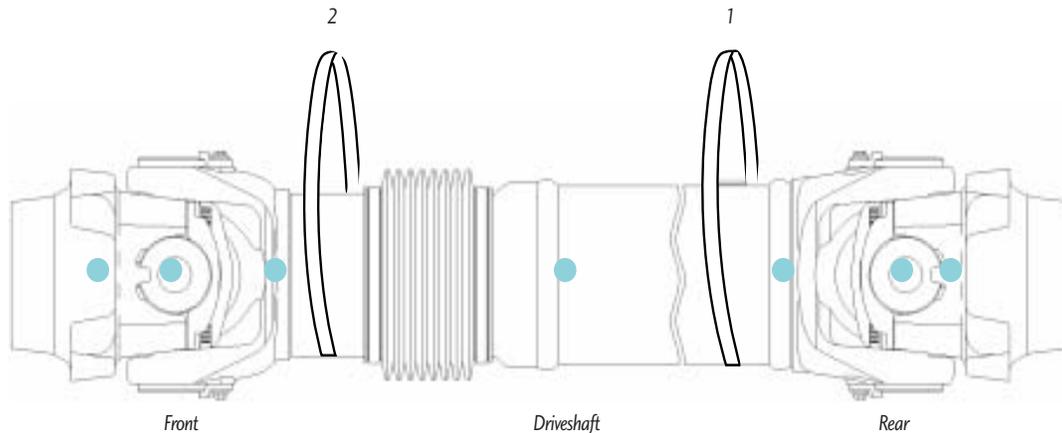
Figure C

3. Be sure first support strap is in place as illustrated in figure C, page 41. Remove the bearing retainers or stamped straps and bolts at rear end. Discard bolts. Discard stamped straps (if applicable). (See photo 26, above.) Reference bolt specifications, Table P, below.

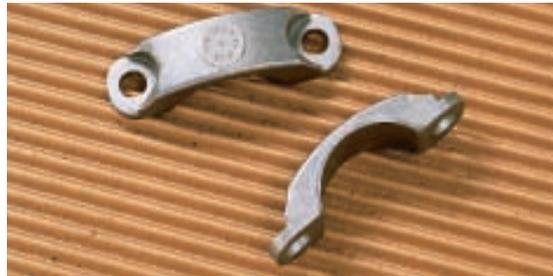
Photo 27, Bearing Retainers

Bearing retainers **CAN** be reused if there is no damage. (See photo 27, below.) If damaged, replace.

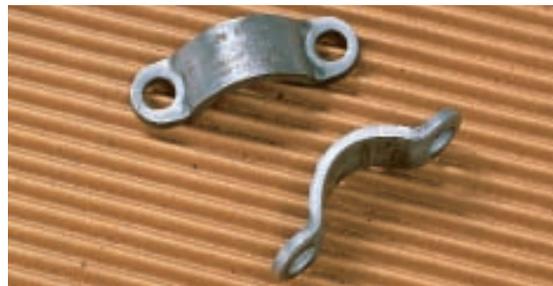
Stamped straps **CANNOT** be reused. (See photo 28, below.) ▲ See warning, below.

Photo 28, Stamped Straps

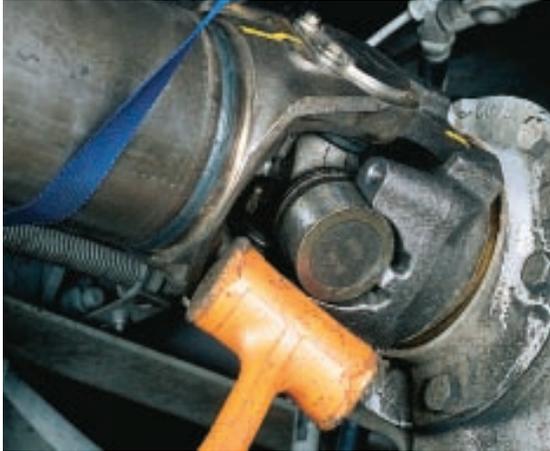
Photo 29

4. It may be necessary to unseat bearing cup assemblies by tapping on yoke or bearing cup with a soft-faced hammer. (See photo 29, above.) Once the bearing cup assemblies are free, collapse the driveshaft until both bearing assemblies clear the open end yoke cross holes. Allow the driveshaft to rest on support strap.

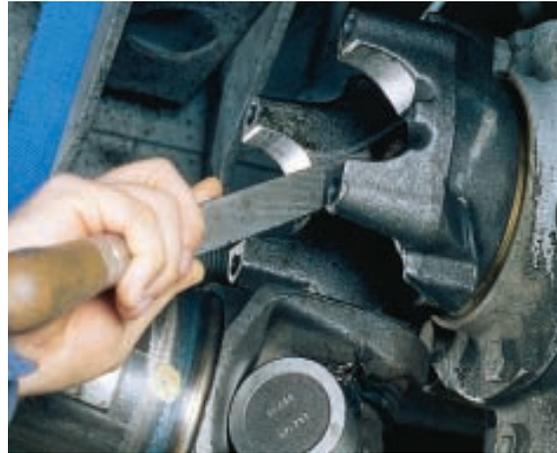
Photo 30

Raised metal or fretting on open yoke cross holes can be removed with a fine-toothed file and/or emery cloth. (See photo 30, above.) ▲ See warning, below.

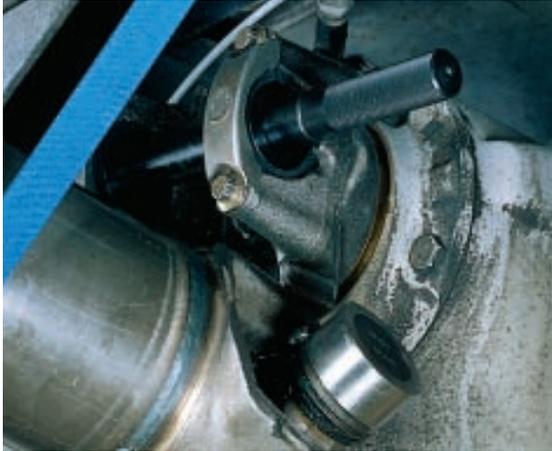
Photo 31

10. Inspect the end yoke cross holes for distortion using the appropriate Spicer alignment bar. (See photo 31, above.) Slide alignment bar through both cross holes simultaneously. If alignment bar will not pass through both cross holes simultaneously, cross holes are distorted and end yoke must be replaced. ▲ See warning, below.

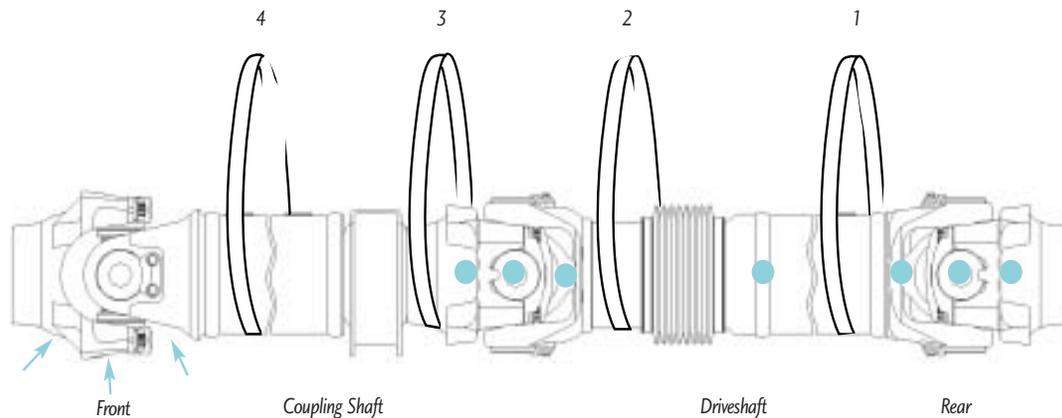
Figure D

3. Be sure first support strap is in place as illustrated in figure D, page 46. Remove the bearing retainers or stamped straps and bolts at rear end. Discard bolts. Discard stamped straps (if applicable). (See photo 32, above.) Reference bolt specifications, Table Q, below.

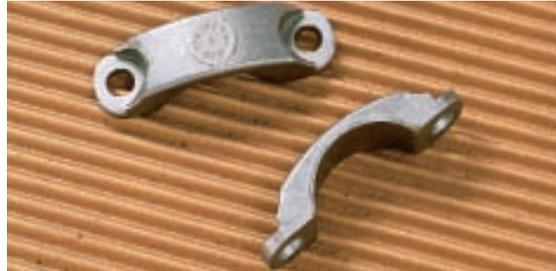
Photo 33, Bearing Retainers

Bearing retainers **CAN** be reused if there is no damage. (See photo 33, below.) If damaged, replace.

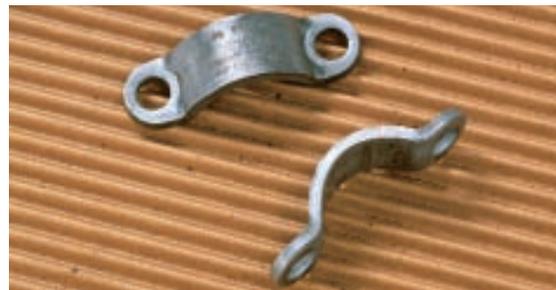
Photo 34, Stamped Straps

Stamped straps **CANNOT** be reused. (See photo 34, below.) ▲ See warning, below.

DO NOT reuse bearing retainer bolts, stamped straps, stamped strap bolts, damaged bearing retainers, or use inferior grade bolts. Reuse of bearing retainer bolts, stamped straps, stamped strap bolts, damaged bearing retainers or the use of inferior grade bolts can cause driveline failure, which can result in separation of driveline from the vehicle. A separated driveline can result in property damage, serious personal injury or death.

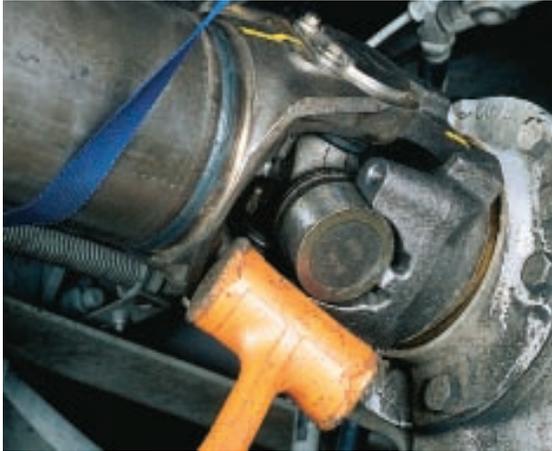
Photo 35

4. It may be necessary to unseat bearing cup assemblies by tapping on yoke or bearing cup with a soft-faced hammer. (See photo 35, above.) Once the bearing cup assemblies are free, collapse the driveshaft until both bearing assemblies clear the open end yoke cross holes. Allow the driveshaft to rest on support strap.

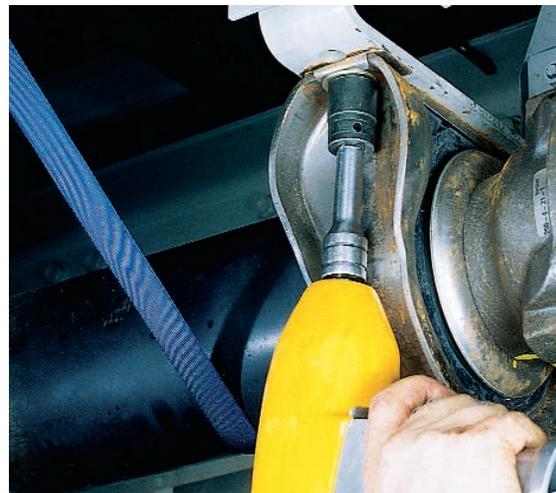
Photo 36

7. Be sure the third support strap is in place, as illustrated in Figure D, page 46. Remove the center bearing bracket bolts and allow the shaft to rest on the support strap. (See photo 36, below.)

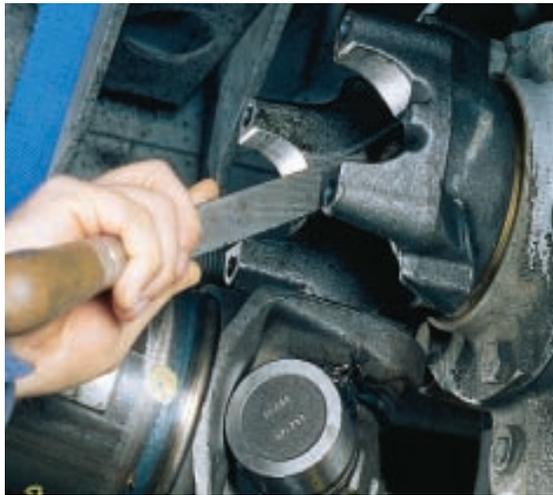
Photo 37

Raised metal or fretting on open yoke cross holes can be removed with a fine-toothed file and/or emery cloth. (See photo 37, above.) ▲ See warning, below.

DO NOT deform yoke cross holes by removing excessive metal. Raised metal or deformed yoke cross holes can be a cause of cross and bearing failure, which can result in separation of driveline from vehicle. A separated driveline can result in property damage, serious personal injury or death.

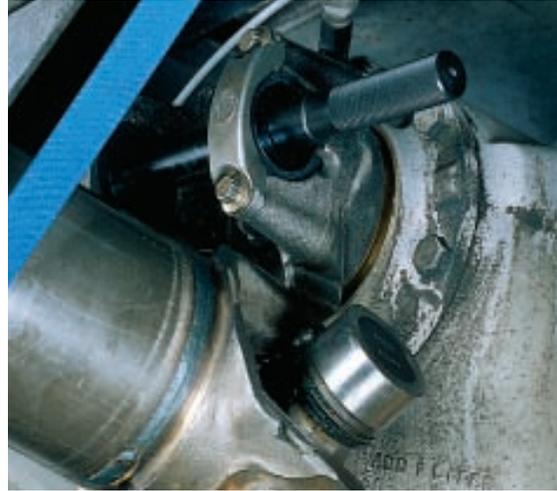
Photo 38

13. Inspect the end yoke cross holes for distortion using the appropriate Spicer alignment bar. (See photo 38, above.) Slide alignment bar through both cross holes simultaneously. If alignment bar will not pass through both cross holes simultaneously, cross holes are distorted and yoke must be replaced. ▲ See warning, below.

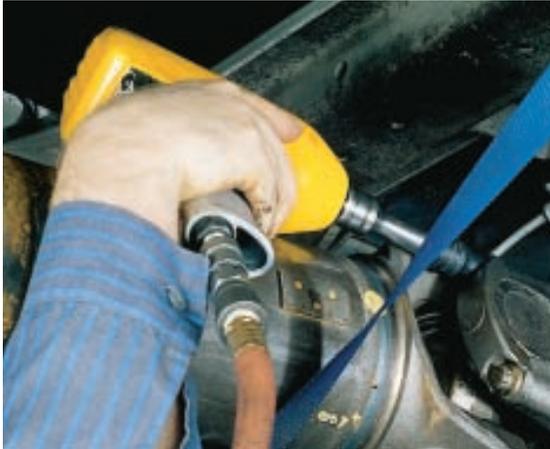
Photo 39

3. Be sure first support strap is in place as illustrated in Figure E, page 51. Remove the bearing retainers or stamped straps and bolts at rear end. Discard bolts. Discard stamped straps (if applicable). (See photo 39, above.) Reference bolt specifications, Table R, below.

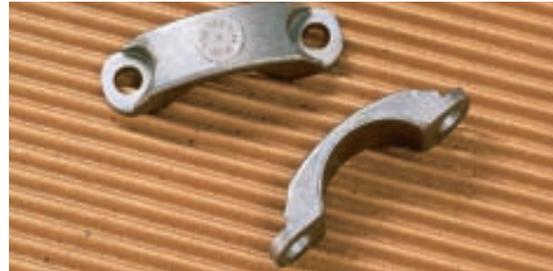
Photo 40, Bearing Retainers

Bearing retainers **CAN** be reused if there is no damage. (See photo 40, below.) If damaged, replace.

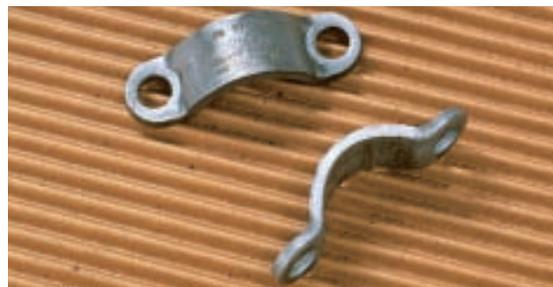
Photo 41, Stamped Straps

Stamped straps **CANNOT** be reused. Discard bolts. (See photo 41, below.) ▲ See warning, below.

DO NOT reuse bearing retainer bolts, stamped straps, stamped strap bolts, damaged bearing retainers, or use inferior grade bolts. Reuse of bearing retainer bolts, stamped straps, stamped strap bolts, damaged bearing retainers or the use of inferior grade bolts can cause driveline failure, which can result in separation of driveline from the vehicle. A separated driveline can result in property damage, serious personal injury or death.

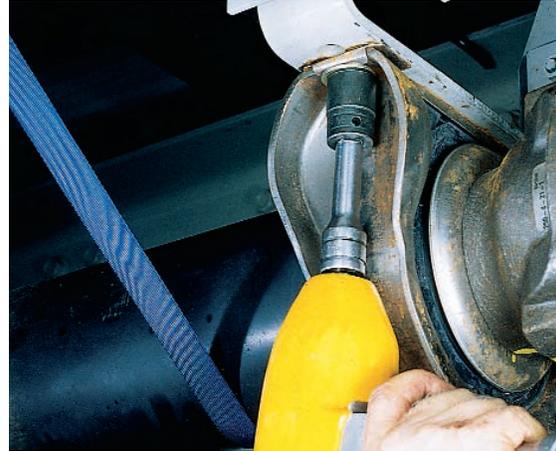
Photo 43

7. Position third support strap as illustrated in Figure E, page 51. Remove the center bearing bracket bolts and allow the shaft to rest on the support strap. (See photo 43, above.)

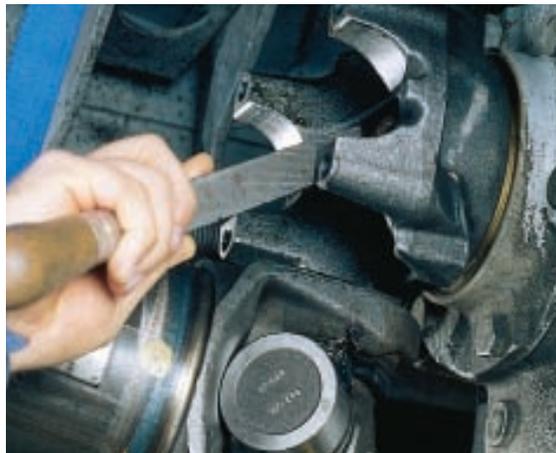
Photo 44

Raised metal or fretting on open yoke cross holes can be removed with a fine-toothed file and/or emery cloth. (See photo 44, below.) ▲ See warning, below.

DO NOT deform yoke cross holes by removing excessive metal. Raised metal or deformed yoke cross holes can be a cause of cross and bearing failure, which can result in separation of driveline from vehicle. A separated driveline can result in property damage, serious personal injury or death.

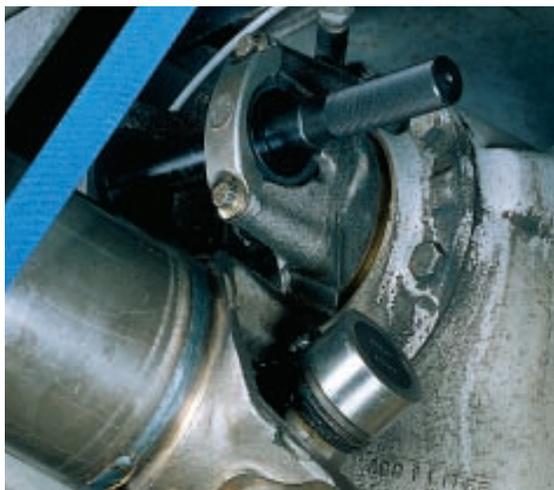
Photo 45

16. Inspect the end yoke cross holes for distortion using the appropriate Spicer alignment bar. (See photo 45, above.) Slide alignment bar through both cross holes simultaneously. If alignment bar will not pass through both cross holes simultaneously, cross holes are distorted and yoke must be replaced. ▲ See warning, below.

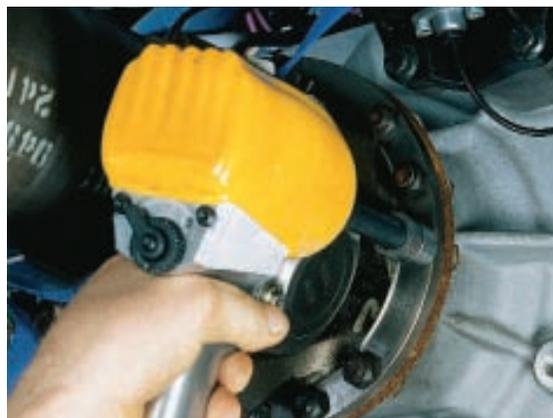
Photo 46

3. Be sure first support strap is in place as illustrated in Figure F or G, page 57. Remove and discard flange bolts, washers and nuts at **rear** end. Reference hardware specifications, Table S, above. (See photo 46, below.)

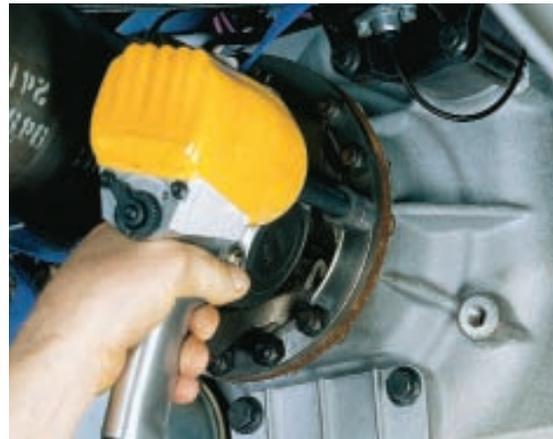
Photo 47

3. Be sure first support strap is in place as illustrated in Figures H or J, page 61. Remove and discard flange bolts, washers and nuts at front end. (See photo 47, right.)

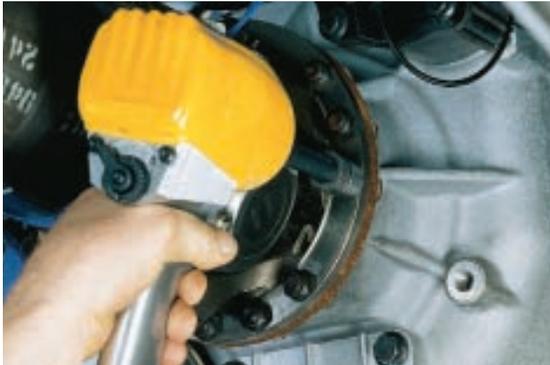
Photo 48

3. Be sure the first support strap is in place as illustrated in Figure K or L, page 65. Remove and discard flange bolts, washers and nuts at rear end. (See photo 48, page 67.)

4. It may be necessary to unseat pilot or serrated connection by tapping on one side of flange with a soft-faced hammer. Once the connection is free, collapse the driveshaft and allow it to rest on support strap.

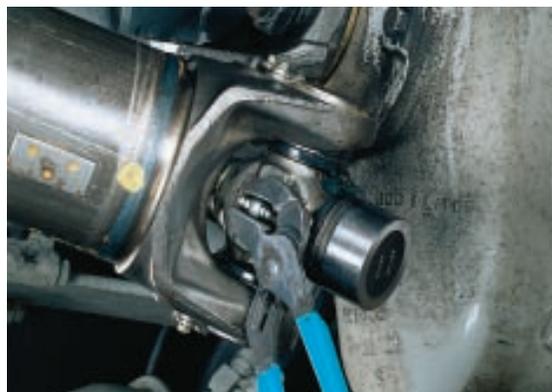
Photo 49

1. Tilt the universal joint kit or flange yoke and universal joint kit to allow access to effected grease zerk (nipple) fitting or plug. Using pliers or an open-ended wrench, turn grease zerk (nipple) fitting or plug counter-clockwise, until it is removed from the journal cross. (See photo 49, below.) Discard the grease zerk (nipple) fitting or plug.

3. Install new grease zerk (nipple) fitting (Spicer part number 232830) or plug. Tighten to minimum 15 ft. lbs. (20 Nm). Then continue to turn only until grease zerk (nipple) fitting is correctly positioned. (See photo 49 for correct grease zerk (nipple) fitting position.) ▲ See warning, below.

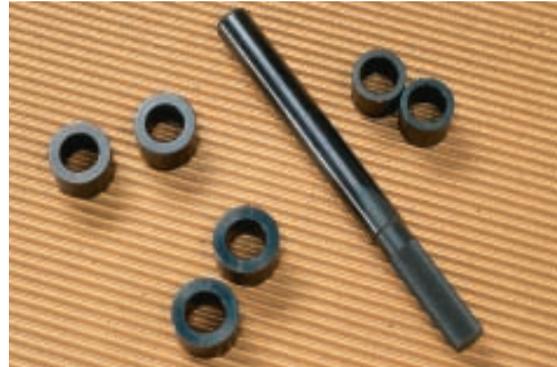
Photo 50, Spicer Alignment Bar Kit Quick Disconnect Style

- Support Straps
- Ratchet or Air Gun
- Appropriate Spicer Alignment Bar
(See photo 50 or 51, right.)

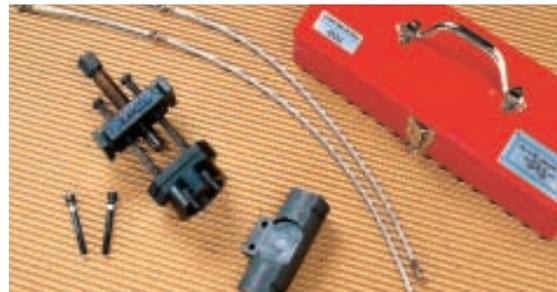
Photo 52

- Three-ton (minimum) Arbor Press
(for Spicer Life Series™ 55, 70, 90, 100, 140,
170 & 250) and
Bearing Cup Spacer, and
Push Rod
or
- J & J Universal Joint Puller 4LIFE (see photo 52, right)
(for Spicer Life Series™ 140, 170 & 250)
1-800-221-4903
[Outside U.S. and Canada 215-256-9300](tel:215-256-9300)
or
- Tiger Tool MARK 1A (see photo 53, right)
or TGLS-597 (not shown)
(for Spicer Life Series™ 140, 170 & 250)
1-800-661-4661
[Outside U.S. and Canada 604-855-1133](tel:604-855-1133)

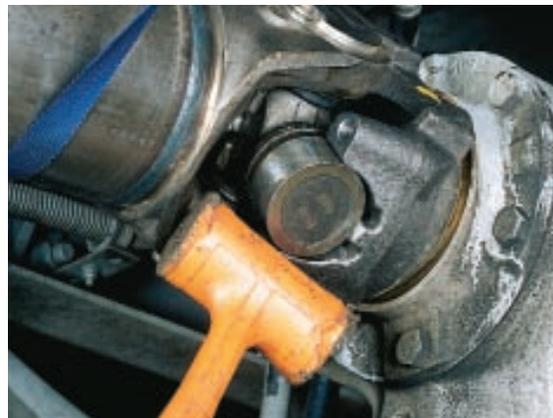
Photo 55

4. It may be necessary to unseat bearing cup assemblies, pilot or serrated connection by tapping on tube yoke or bearing cup with a soft-faced hammer. (See photo 55, below.) Once the bearing cup assemblies or connections are free, collapse the driveshaft until both bearing cup assemblies clear the open cross holes or flange yoke pilot is disconnected. Allow the driveshaft to rest on support strap.

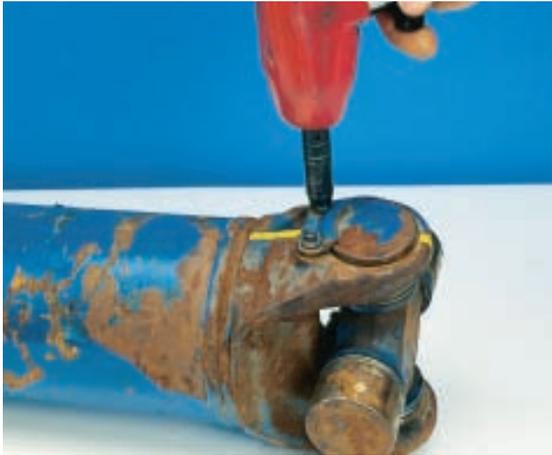
Photo 56, Quick Disconnect Style

15. Remove and discard spring tabs and bolts. Reference bolt specifications, Table X, right. (See photos 56 or 57, above). **▲** See warning, below.

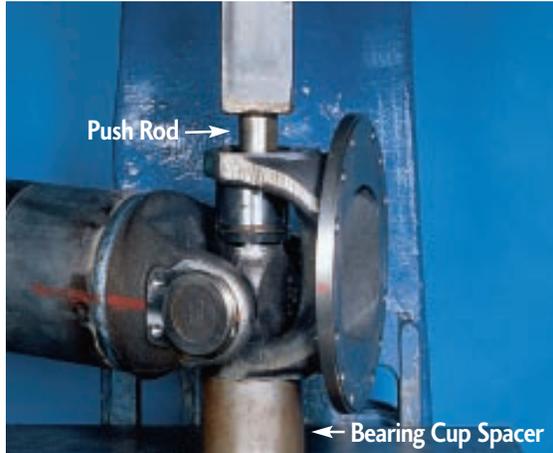
Photo 58, Companion Flange Style

16. To remove flange yoke, place bearing cup spacer onto the base of the arbor press and under flange yoke. (See photo 58, above.) If the arbor is larger than the bearing cup diameter, a smaller diameter push rod will be needed to avoid damaging the yoke or bearing.

Using an arbor press, press down on the upper bearing cup assembly until the shoulder of the journal cross makes contact with the inside of flange yoke ear. (See photo 58, above.)

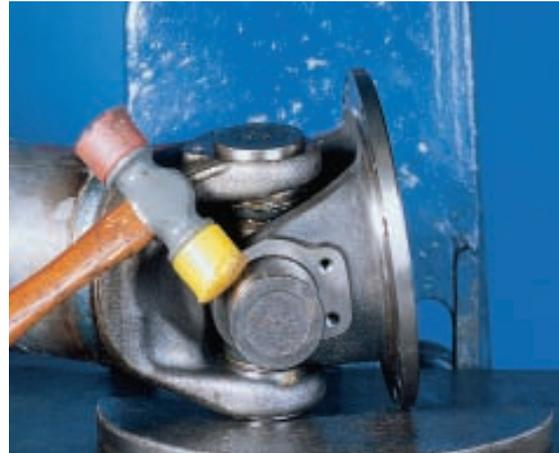
Photo 59, Companion Flange Style

17. Bearing cup is not designed to drop out of flange yoke. It will be necessary to use a soft-faced hammer to tap the partially pressed-out bearing cup from side to side, to “walk” the bearing cup out of flange yoke ear. (See photo 59, top right.)

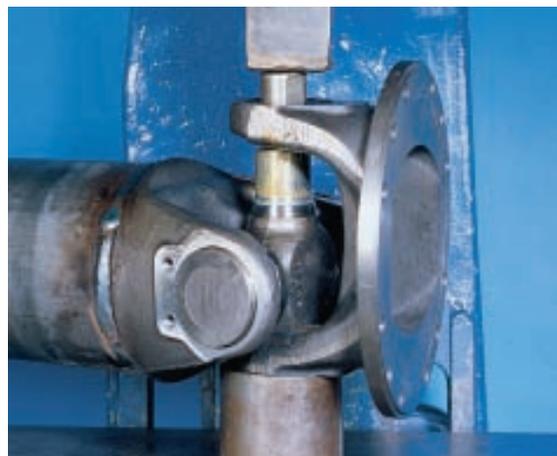
Photo 60

18. Place flange yoke in arbor press with remaining bearing cup face down. Using a push rod, press on end of the journal cross trunnion until the shoulder of the journal cross makes contact with the inside of flange yoke ear. (See photo 60, below.) Repeat step 17.

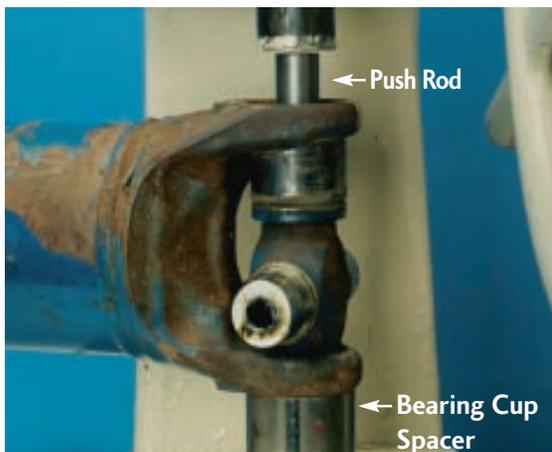
Photo 63

Using an arbor press, press down on the upper bearing cup assembly until the shoulder of the journal cross makes contact with the inside of the yoke ear. (See photo 63, below.)

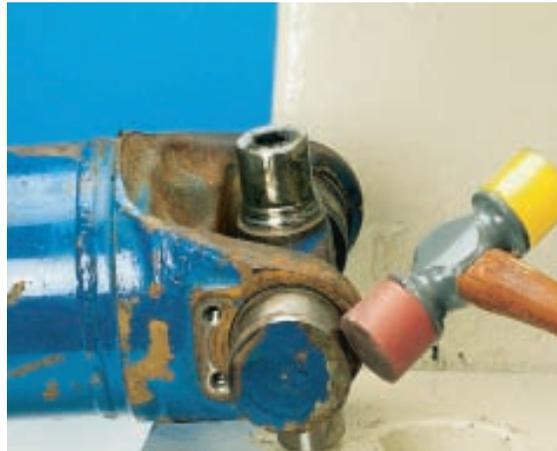
Photo 64

22. The bearing cup is not designed to drop out of the yoke. It will be necessary to use a soft-faced hammer to tap the partially pressed-out bearing cup from side to side, to “walk” the bearing cup out of the yoke ear. (See photo 64, below.)

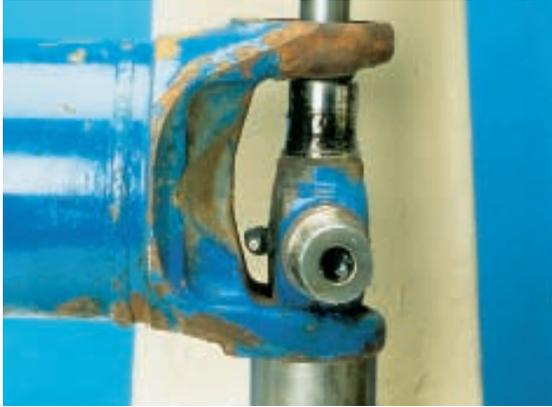
Photo 65

23. Place the yoke in the press, with the remaining bearing cup face down. (See photo 65, above.) Using a push rod, press on end of the journal cross trunnion. Continue to press down on the journal cross trunnion until the shoulder of the journal cross makes contact with the inside of the yoke ear.

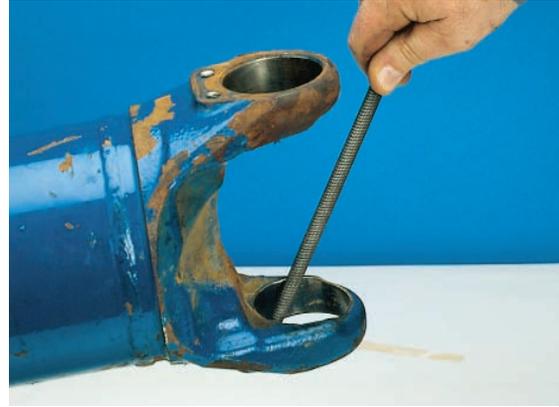
Photo 66

26. Inspect the tube yoke and flange yoke (if applicable) cross hole surfaces for damage or raised metal. Raised metal or fretting can be removed from yoke cross holes with a fine-toothed file and/or emery cloth. (See photo 66, top right.) ▲ See warning, below.

DO NOT deform yoke cross holes by removing excessive metal. Raised metal or deformed yoke cross holes can be a cause of cross and bearing problems and can result in separation of driveline from vehicle. A separated driveline can result in property damage, serious personal injury or death.
