**COMPANION FLANGE/FLANGE YOKE STYLE
(S.A.E., DIN AND T-TYPE)
SPICER LIFE SERIES 55, 70, 90, 100, 140, 170 & 250**

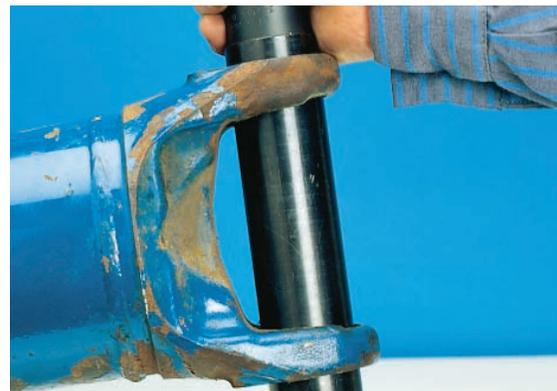
Photo 67

27. Inspect the tube yoke or flange yoke (if applicable) for distorted cross holes using an appropriate Spicer alignment bar. Slide alignment bar through both cross holes simultaneously. If alignment bar will not pass through both cross holes simultaneously, the cross holes are distorted and the shaft assembly must be replaced. (See photo 67, below.)

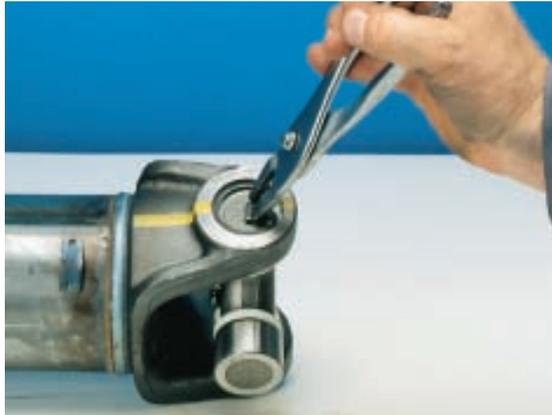
Photo 70

15. Using snap-ring pliers, remove all snap rings. (See photo 70, above.) If snap rings are severely corroded or out-of-round, snap rings must be replaced. ▲ See warning, below.

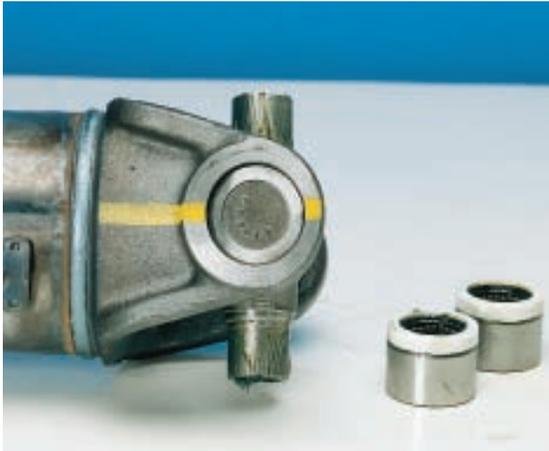
Photo 71, Correct Positioning

21. Make sure the universal joint cross assembly is not tilted in yoke. (See photos 71, top left, and 72, center left.)

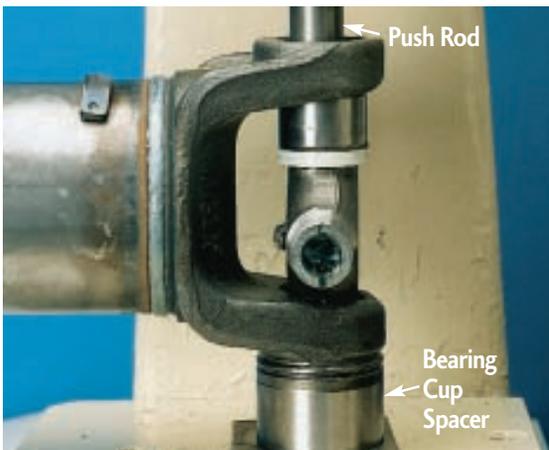
Photo 73

Using the arbor press, press down on the upper bearing cup assembly until the shoulder of the journal cross makes contact with the inside of the yoke ear. (See photo 73, bottom left.) Bearing cup is not designed to drop out of yoke.

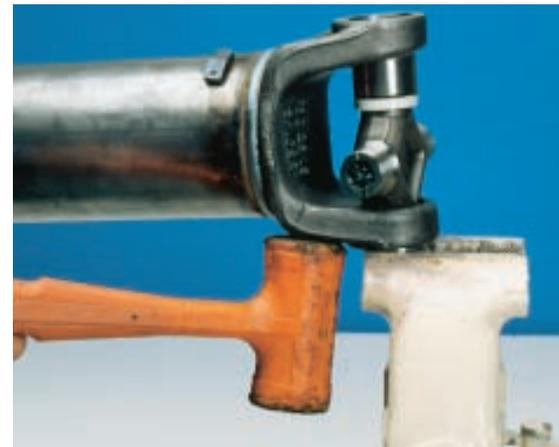
Photo 74

23. Grip the bearing cup in bench vice. (See photo 74, below.) Strike the yoke ear with a soft-faced hammer until bearing is removed.

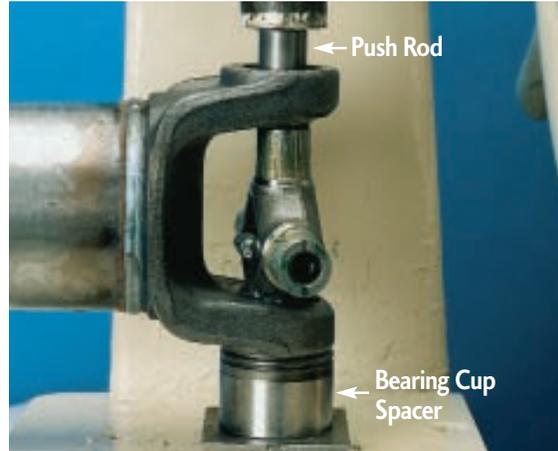
Photo 75

24. Place the yoke in the arbor press with remaining bearing cup face down. Using a push rod, press on the end of journal cross trunnion. (See photo 75, top right.) Continue to press down on journal cross trunnion until the shoulder of the journal cross makes contact with the inside of yoke ear. Bearing cup is not designed to drop out of yoke. Repeat step 23.

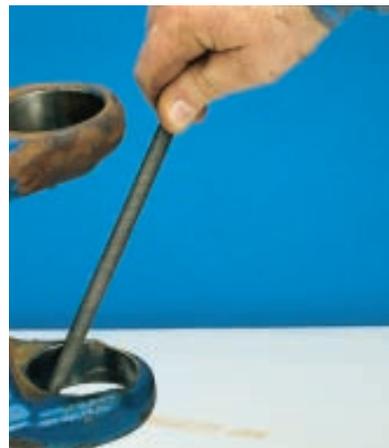
Photo 76

26. Inspect the tube yoke and flange yoke (if applicable) cross hole surfaces for damaged or raised metal. Raised metal or fretting can be removed from yoke cross holes with a fine-toothed file and/or emery cloth. (See photo 76, right.) ▲ See warning, below.

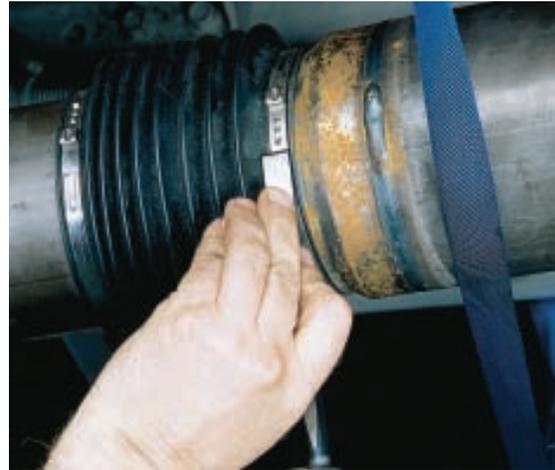
Photo 77

3. Remove and discard both boot clamps. Clamps may be separated using a chisel to disengage locking hooks. (See photo 77, above.) **DO NOT reuse clamps.** ▲ See warning, below.

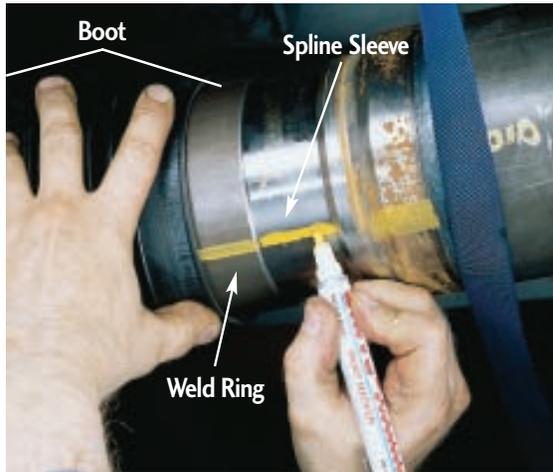
Photo 78

5. Mark spline sleeve and end of weld ring with a marking stick, paint marker or other legible marking device. (See photo 78, above.) This assures that the slip member can be reassembled in its original phased condition. ▲ See warning, below.

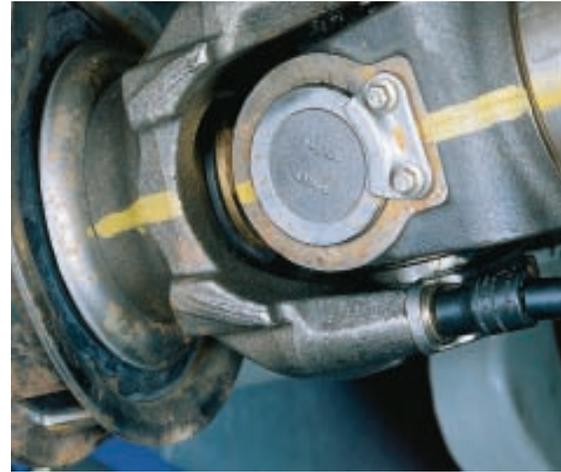
Photo 79

6. For Quick Disconnect™ style, remove bearing retainers and bolts or stamped straps and bolts at center bearing end fitting. Reference bolt specifications, Table AA, right. (See photo 79, top right.) Discard bolts.

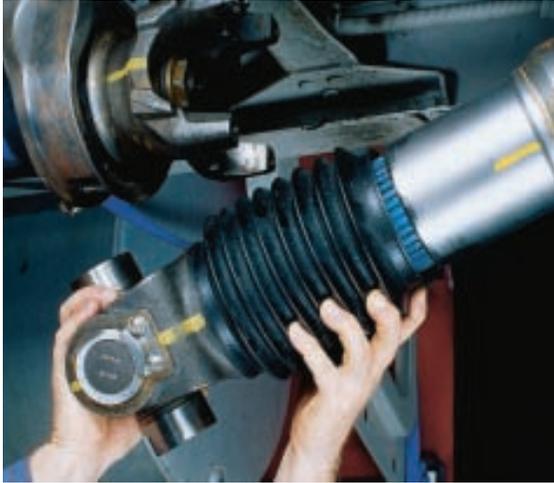
Photo 80

8. Remove the yoke shaft and boot from the spline sleeve. Discard boot. (See photo 80, above.) ▲ See warning, below.

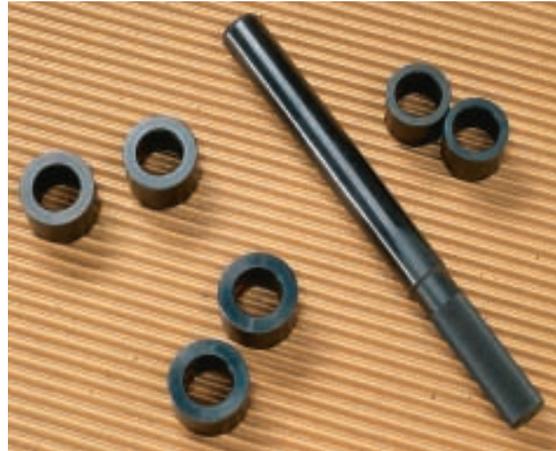
Photo 81, Spicer Alignment Bar Kit, Quick Disconnect Style

- Support Straps
- Bearing Puller
- Flange or Yoke Puller
- 6-Point Socket for Midship Nut
- 12-Point Sockets
 - English 3/8," or
 - Metric 12mm
- Spicer Alignment Bar (see photo 81 or 82, top right and right)

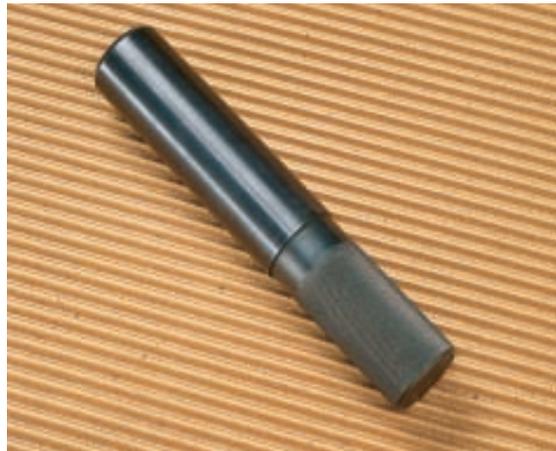
Photo 82, Spicer Alignment Bar, Companion Flange/Flange Yoke Style
